Marion County, Florida

**Finding of Necessity
Silver Springs Proposed Redevelopment Area**

April 2012

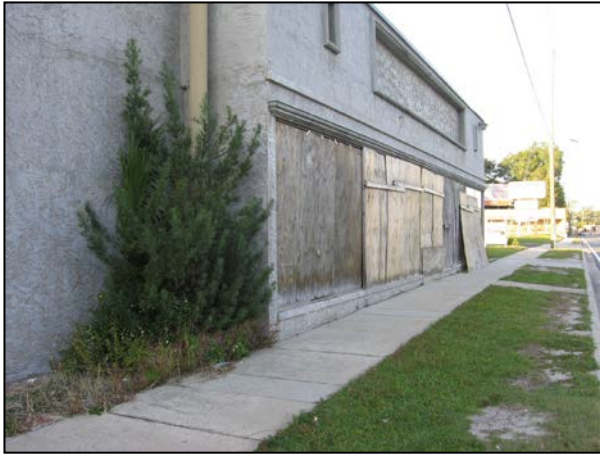
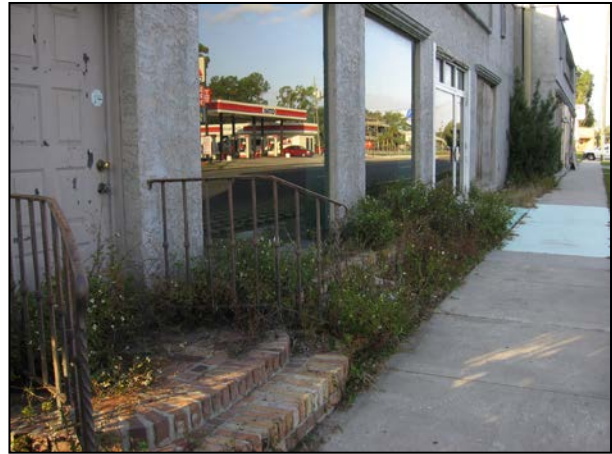
The photos below show the extent of damage to the structure from vacancy. All building front visibility and access have been covered by plywood. The windows behind the plywood are shattered. The structure, consisting of a connected strip of commercial properties, is located on Silver Springs Blvd. and Highway 40. According to the definition of a deteriorated property, this structure exhibits broken/boarded-up windows, overgrown grass, and is in need of maintenance to prevent hazardous conditions.

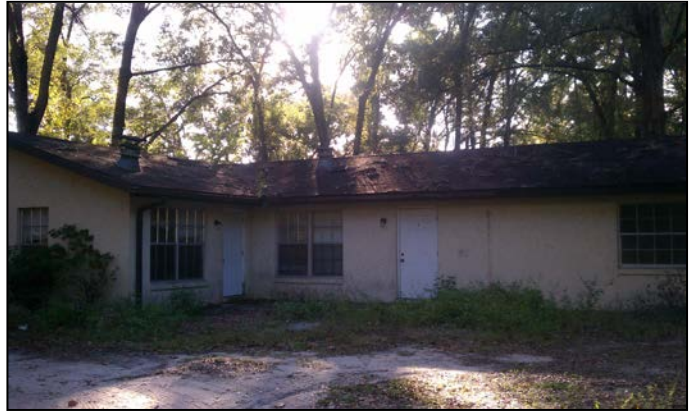
This photo shows a vacant duplex exhibiting signs of deterioration including a worn roof, unpaved dirt driveway, and overgrown grass. This property is located on the SW corner of NE 35th St. and NE 56th Ave.

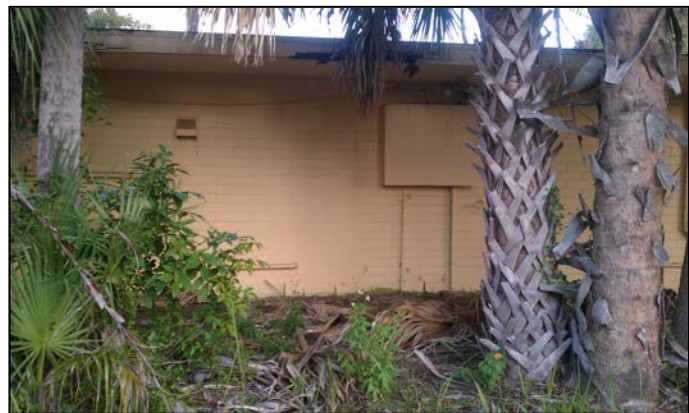
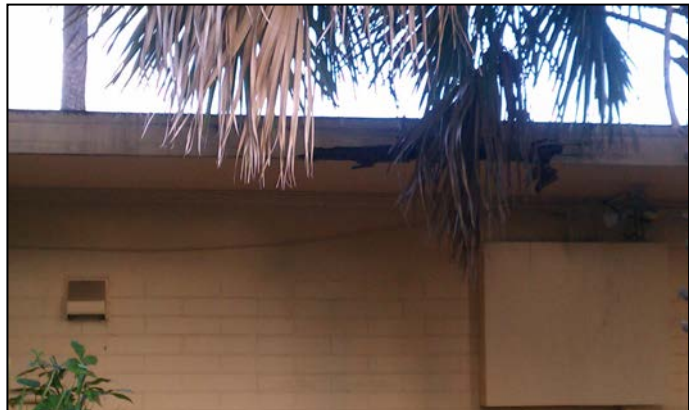
The photos to the right illustrate the backside of a motel. Deterioration of the structure is most noticeable on fascia boards of roof. Landscaping has clearly been neglected as well. This property is located on NE 57th Ave, North of Route 40, East of Silver Springs Blvd.

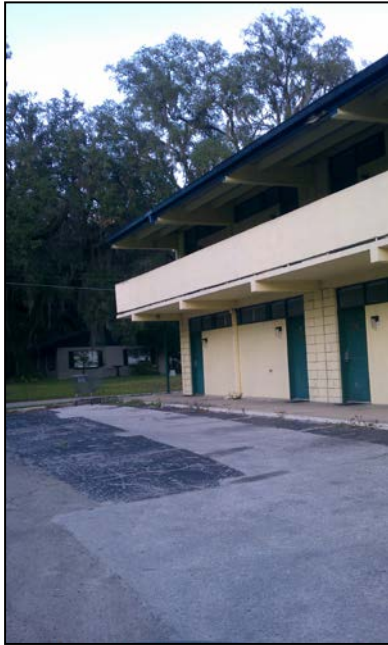
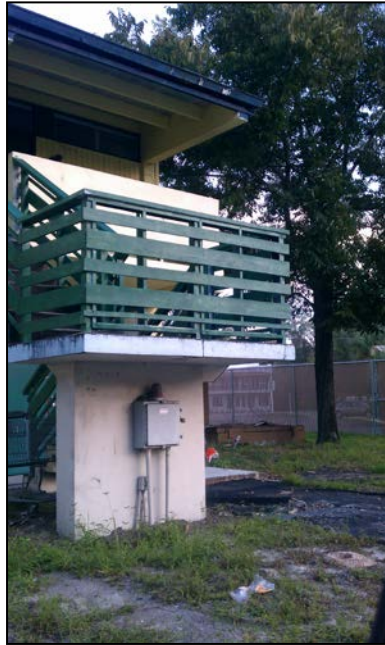
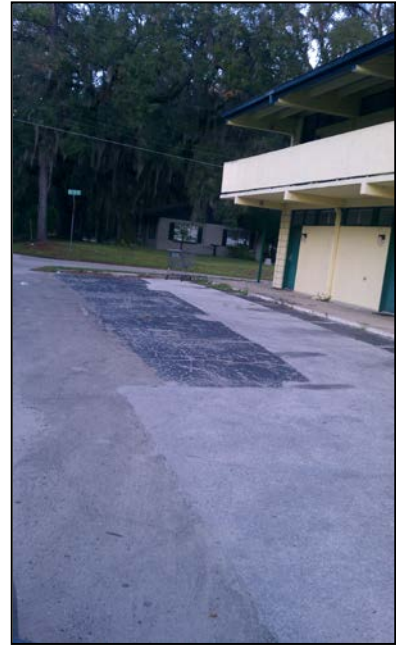
This structure is viewed from the perspective off of Baseline Road. The location is at the intersection of Baseline Road and NE 30th St. The photos below illustrate the deteriorating structure, littered property, and cracked pavement and walkways.

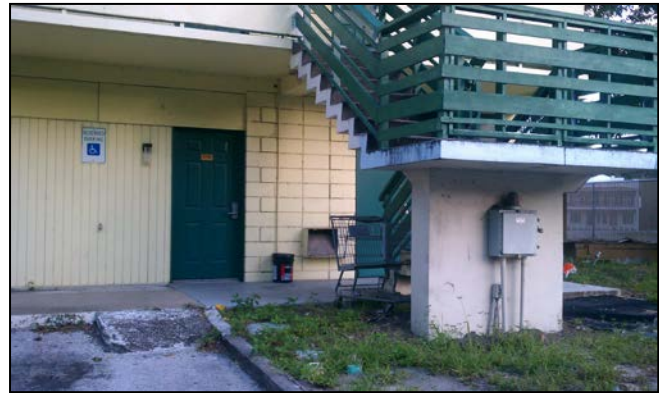
An abandoned shopping cart is evident at the foot of the staircase, cracked pavement and walkways. This site has been neglected by owners and is in need of maintenance to prevent hazardous conditions.

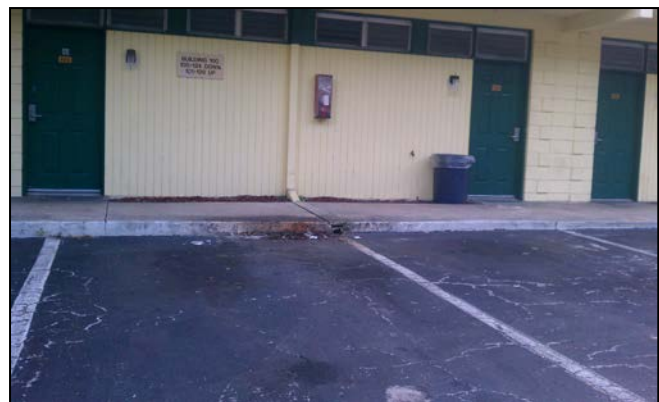
Photo to the left shows the property from the NE 30th St. perspective. Illustrated is another stairwell exhibiting deteriorating conditions as well as the poor condition of the concrete parking lot.

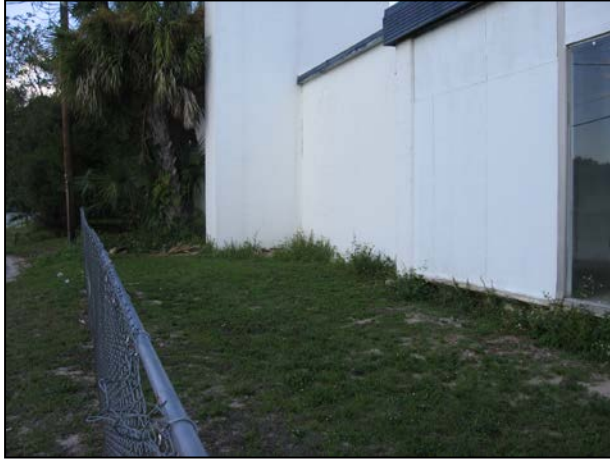
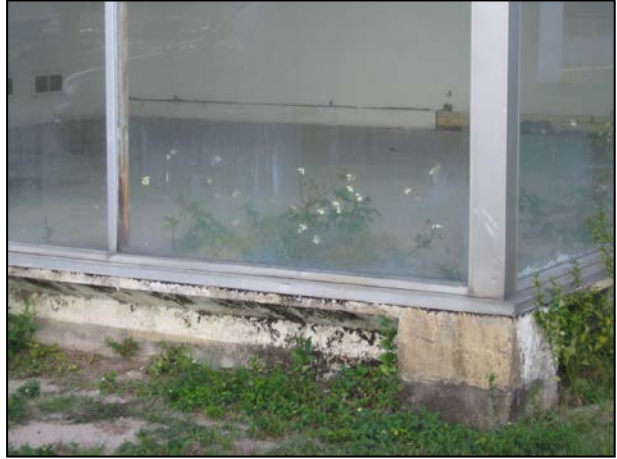
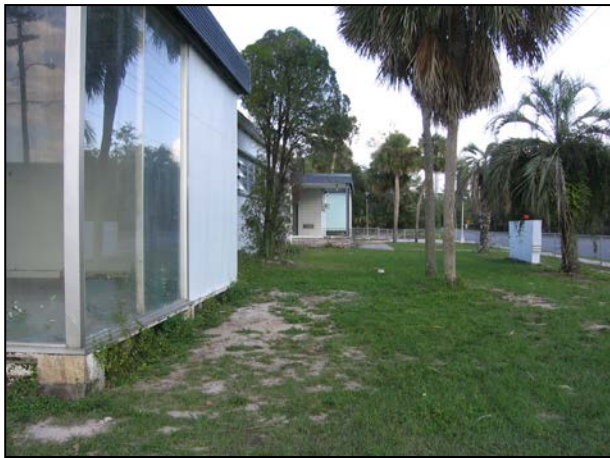
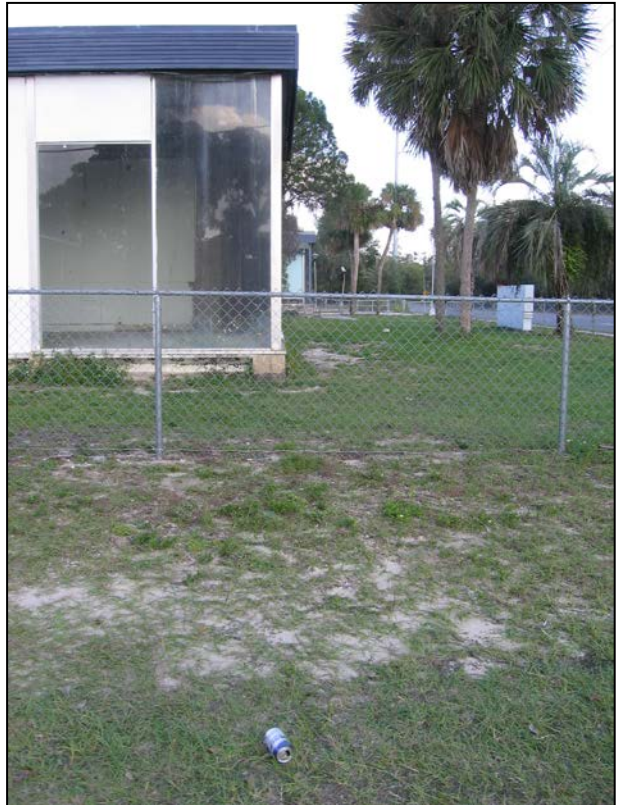
The following photographs were taken of a commercial structure on the NE corner of East Highway 40 (East Silver Springs Blvd.) and NE 58th Ave. This is a vacant, deteriorating commercial structure exhibiting plant growth inside the building, a littered property, mold growth on interior and exterior of structure, visible moisture inside building, broken fence, and overgrown grass.

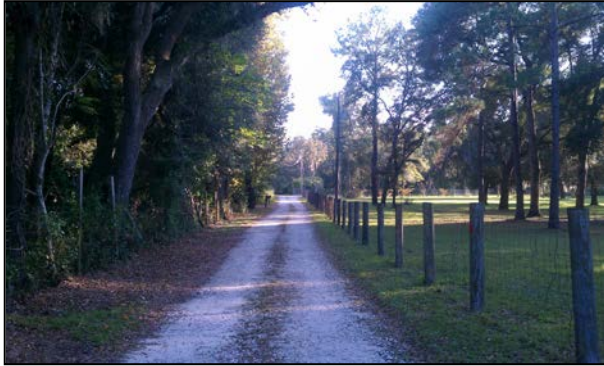
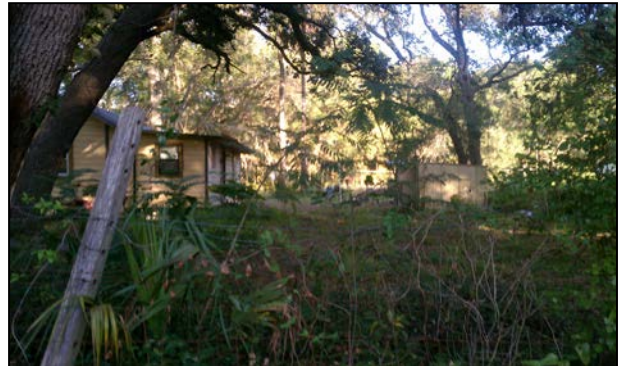
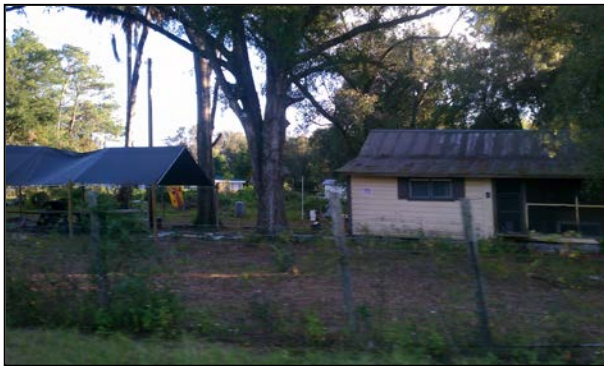
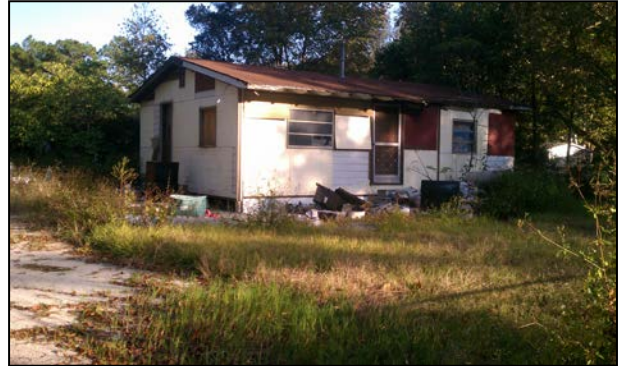
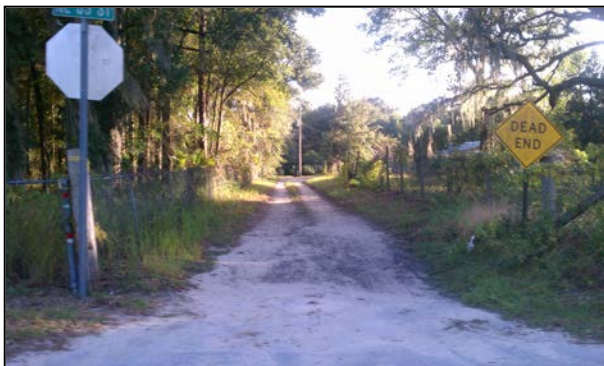
The photos below are all images along NE 52nd Court; House numbers 3400-3410 NE 52nd Court Ocala, FL 34488. The photo location is at the corner of NE 52nd Court and NE 35th St. There are no paved roads and litter along sides of dirt road and around homes. Housing structure appears to have a worn roof, faded paint, overgrown grass, and is in need of maintenance to prevent hazardous conditions.

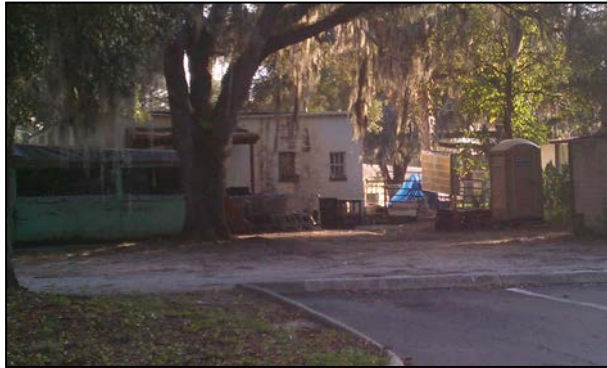
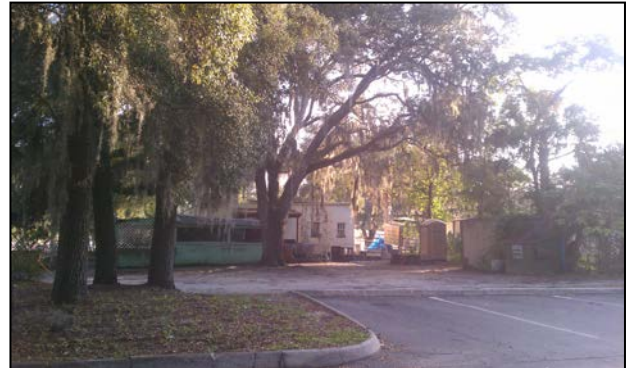
This property is located at 3000 NE 55th Ave., Silver Springs, FL 34488. The property exhibits a conglomeration of defective structures and cluttered outside storage. The parking lot is sub-standard in current condition.

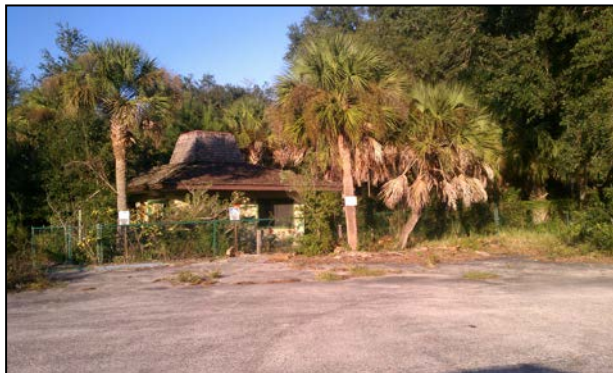
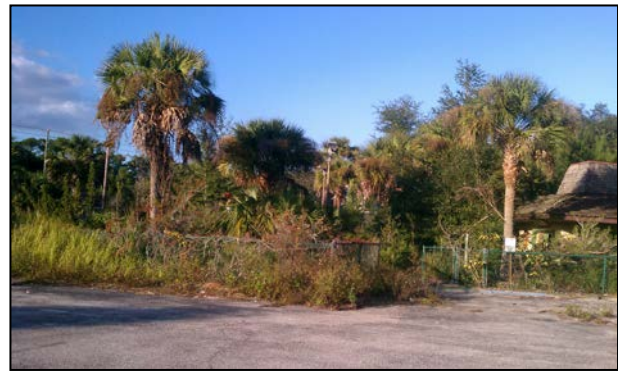
The photos below illustrate a former mini-golf attraction on NE 25th St. This structure displays overgrown grass, worn roof, and a broken fence. The structure has been neglected by property owners and is in need of maintenance to prevent hazardous conditions. Pavement and fence are in need of repair as well.

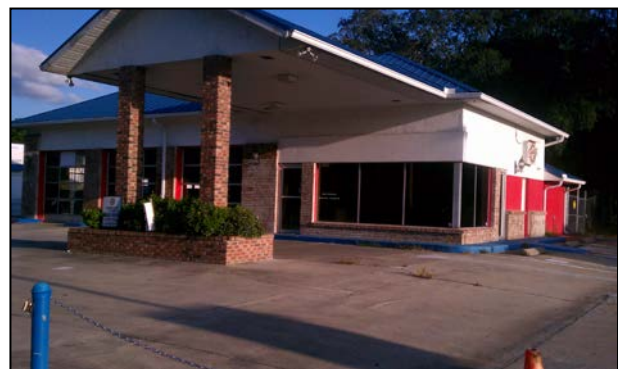
The photo to the right illustrates a vacant commercial building located on East Silver Springs Blvd. Former gun/pawn and used car dealer.

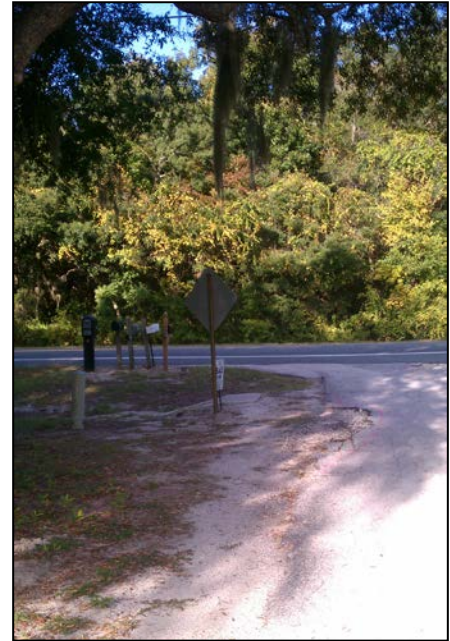
The photograph to the left exhibits deteriorating infrastructure/pavement. This photograph was taken at NE 64th Ave. Rd. at Route 326. Stormwater runoff has etched a path of flow from the pavement, resulting in cracking and deterioration of the pavement.

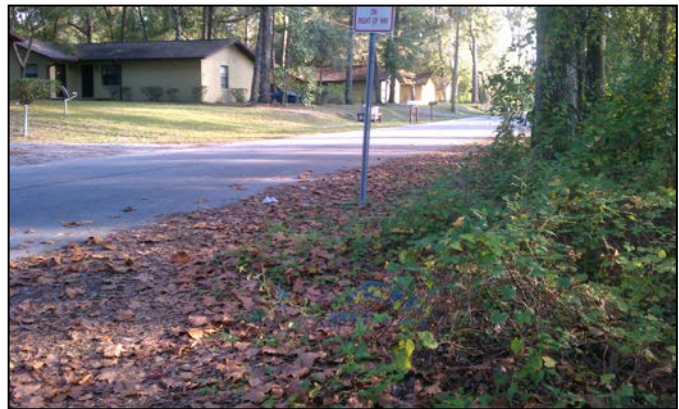
This photograph was taken from the West side of the road, at NE 56th Ave. No sidewalks, gutters, curbs, stormwater infrastructure are present.

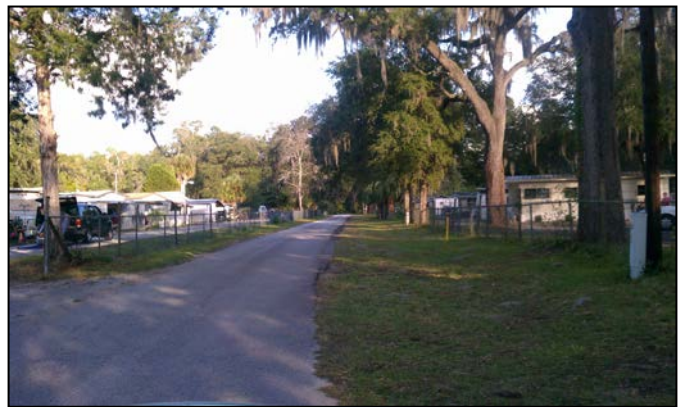
Photographed while looking East on NE 32nd St. at the intersection with NE 56th Ave. This stretch of pavement fails to include curbs, gutters, sidewalks, or any form of stormwater infrastructure.

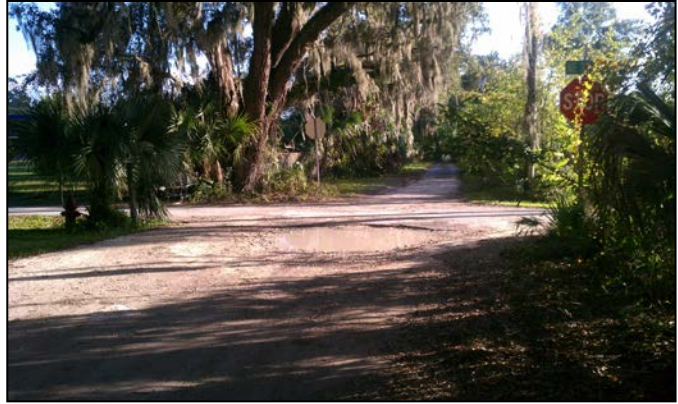
Photographed at the Intersection of NE 57nd Ave. and NE 32nd St. This is a two-lane dirt road in a residential area. As a result of the lack of pavement, severe ponding has occurred in the middle of the road.

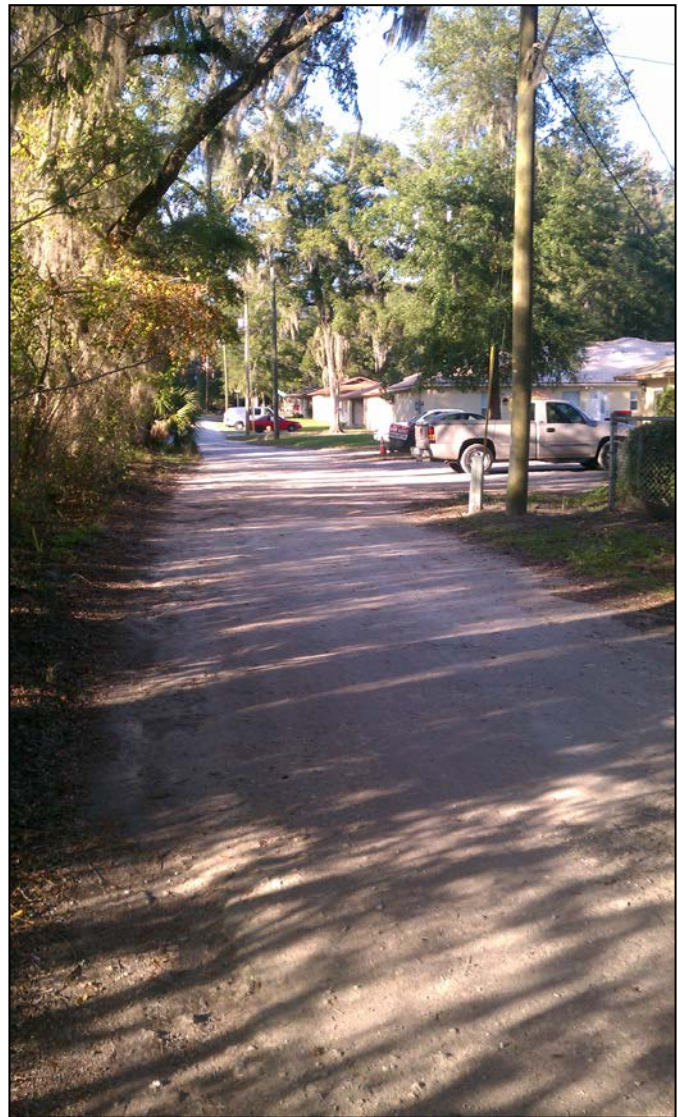
This photograph was taken looking North on NE 57th Ave., from intersection at NE 32nd St. This documents the dirt roads in residential areas of the Study Area. There is no stormwater infrastructure, which compounds the effects precipitation has on ponding in the roadway.

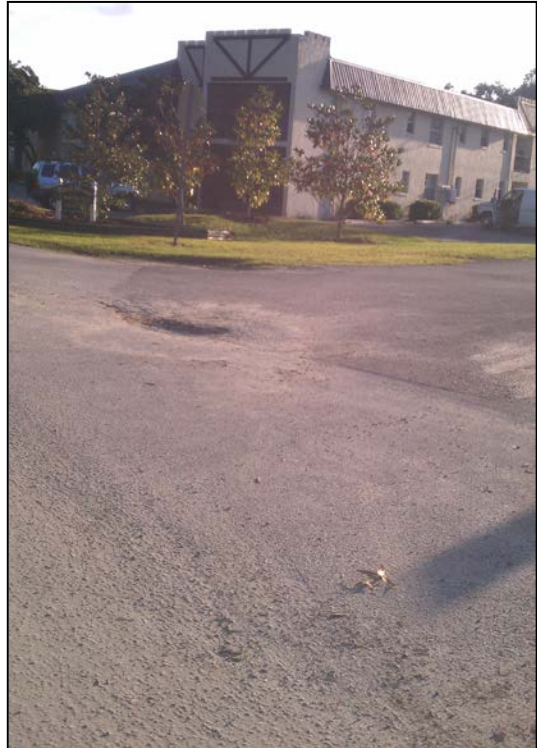
This photograph was taken on the SW corner of NE 29th St. and Silver Springs Airport Rd. A large pothole had formed in the middle of the intersection, clearly due to deterioration and neglect of pavement surface.

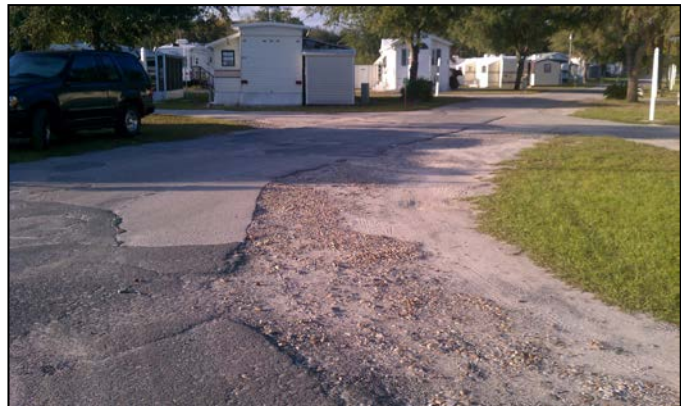
This photograph presents the *Springs RV Resort*. There is major pavement and driveway deterioration occurring on a main entrance roadway residents use daily.

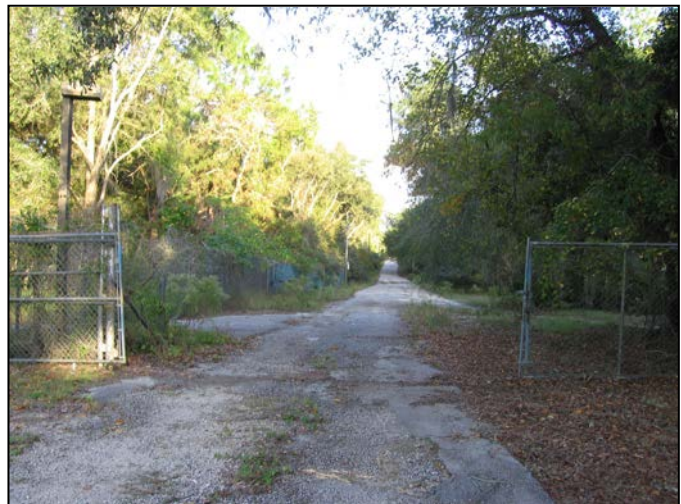
This photograph was taken looking East on NE 24th St. This location is beyond the back of house/maintenance operations center at Silver Springs Park. The pavement is aged and vegetation growing through, as well as evidence of the deterioration of the surface itself.

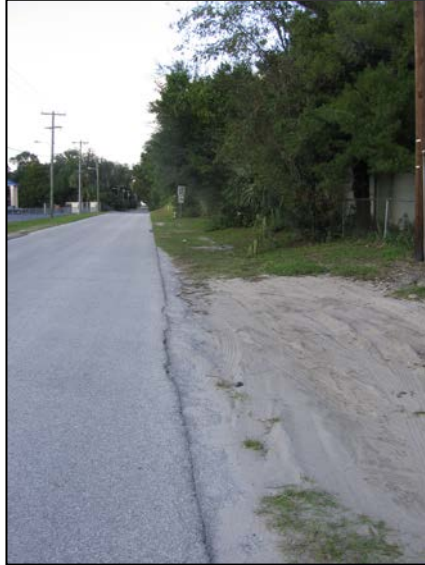
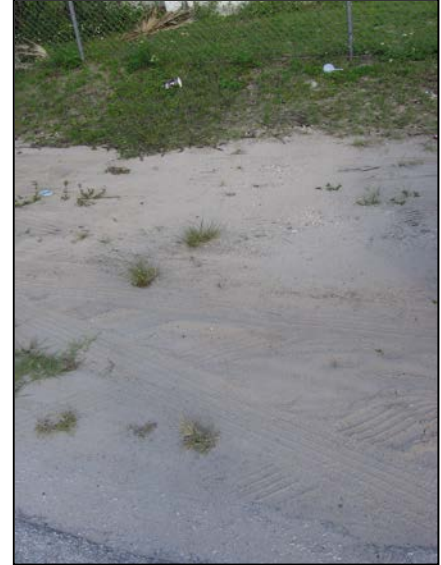
The photographs to the right were taken at the intersection of NE 58th Ave. and Highway 40. There is a lack of curb, gutter, stormwater infrastructure, and sidewalk at this location. Dirt/sand along the roadway has caused the pavement to crack and break apart.

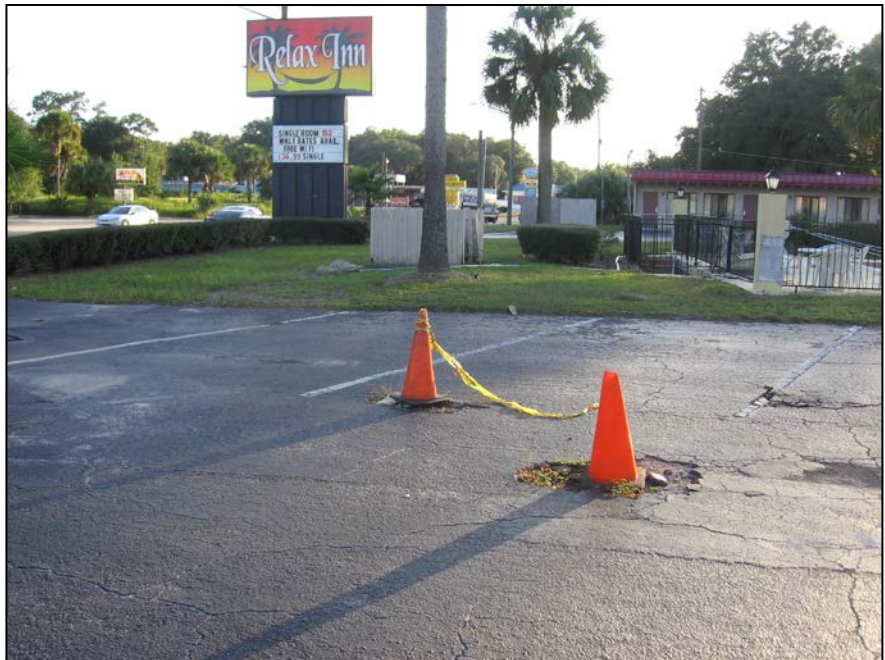
This photograph documents the cracking pavement and pot holes in the parking lot of the *Relax Inn* on East Silver Springs Blvd.

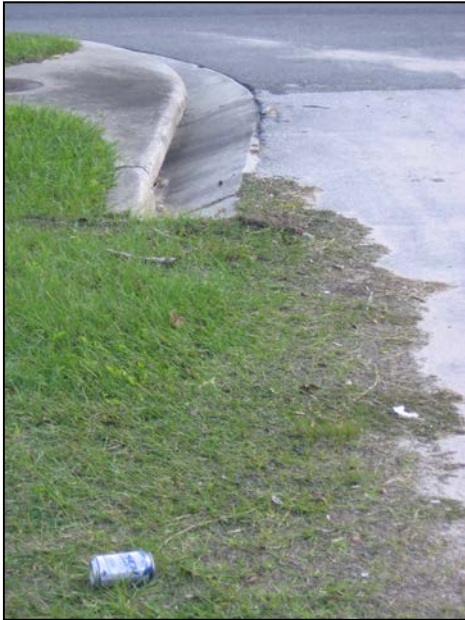
This photo represents the conditions of NE 58th Avenue. There is an inlet to collect stormwater, but no curbs or gutters to continue the system to other inlets.

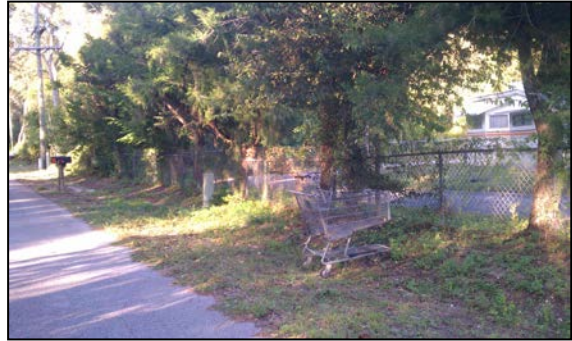
This photograph documents an abandoned shopping cart located on the East side of the street on NE 56th Ave.

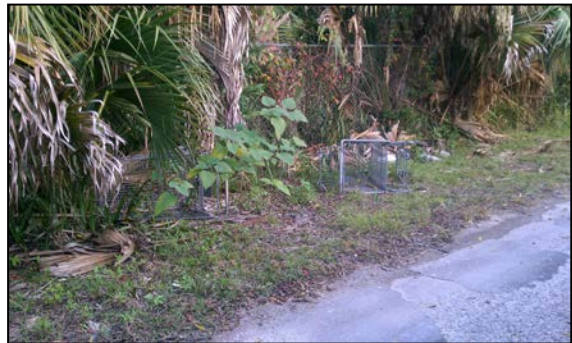
This photograph documents a set of abandoned shopping carts located at NE 57th Ave., to the South of NE 32nd St. on the East side of the street.

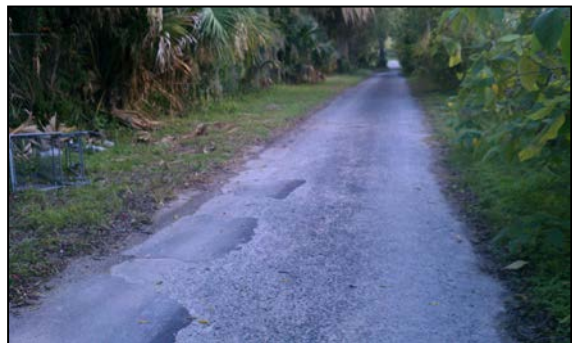
Photograph was taken at NE 57th Ave., to the South of NE 32nd St. on the East side of the street. This is an extension of the previous photograph to illustrate the deteriorating roadway littered with trash. There are no curbs, gutters, or stormwater infrastructure present.

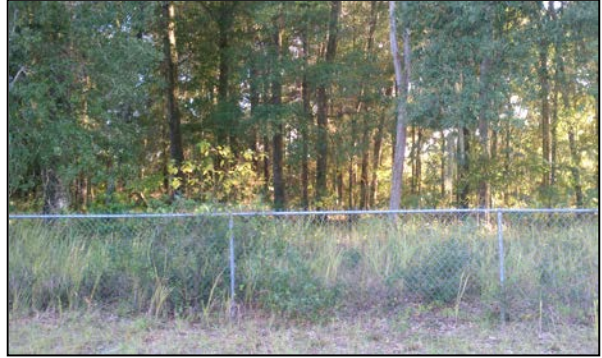
This is a vacant property with overgrown vegetation around the fence. Photograph was taken along NE 35th St.

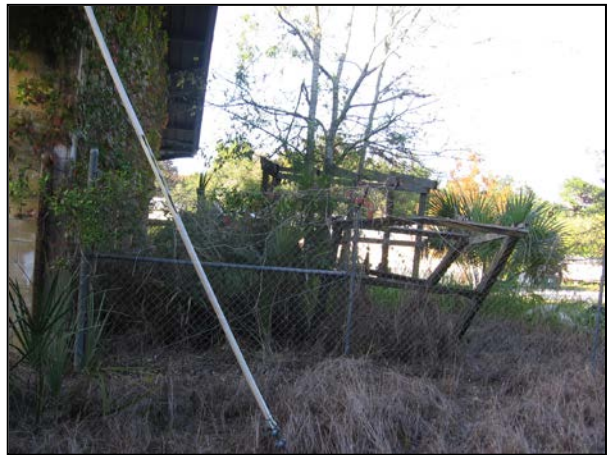
This photograph was taken along Baseline Rd./NE 55th Ave. This is a vacant parcel exhibiting overgrowth and neglect. This is a visual eyesore to the surrounding properties.

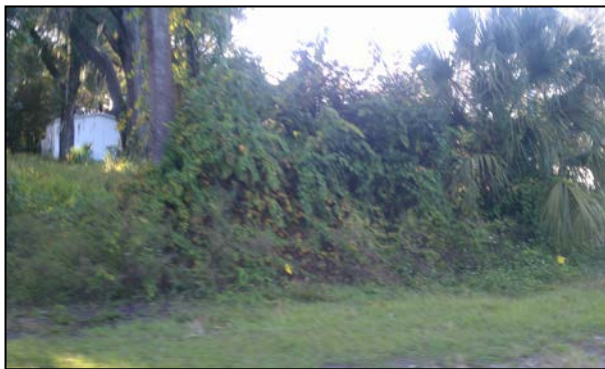
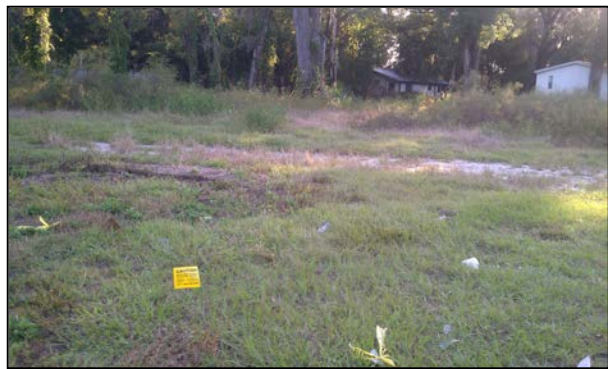
The photos below document a vacant parcel which collects trash and debris. The two photographs below were taken on the corner of Baseline Rd./ NE 55th Ave. and NE 35th St.
